Manhole Inspection Summary

Manhole # S550__031MH

Location Address: **rear 1300 baylis st**

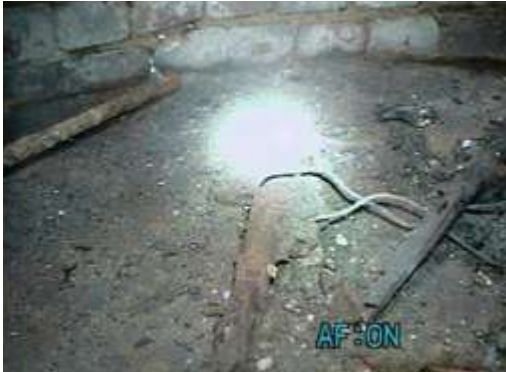
misc

channel debris

bench debris

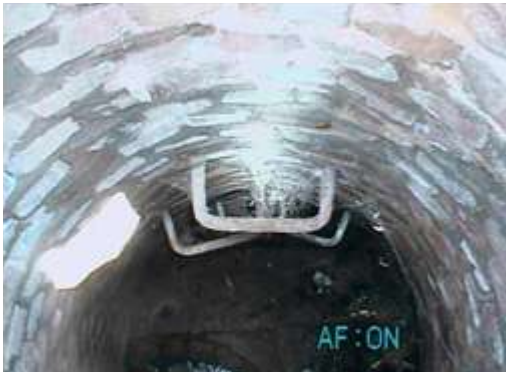
Defect 2

Steps Count: **5** Missing: **1** ☒ **Corroded**

Chimney, frame adj

steps

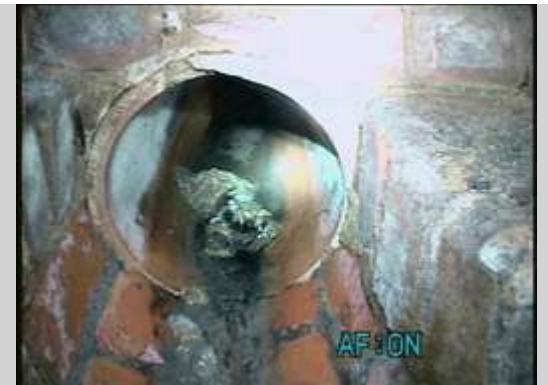
9 O'Clock Inflow

Deposits: ☐ None ☐ Mud ☐ Sludge ☒ **Debris** ☐ Grease

Silt Depth: 2 (in.) Deposits Extent: **Light**
